County-wide Stream Inventory Data Analysis

Executive Summary August 2011

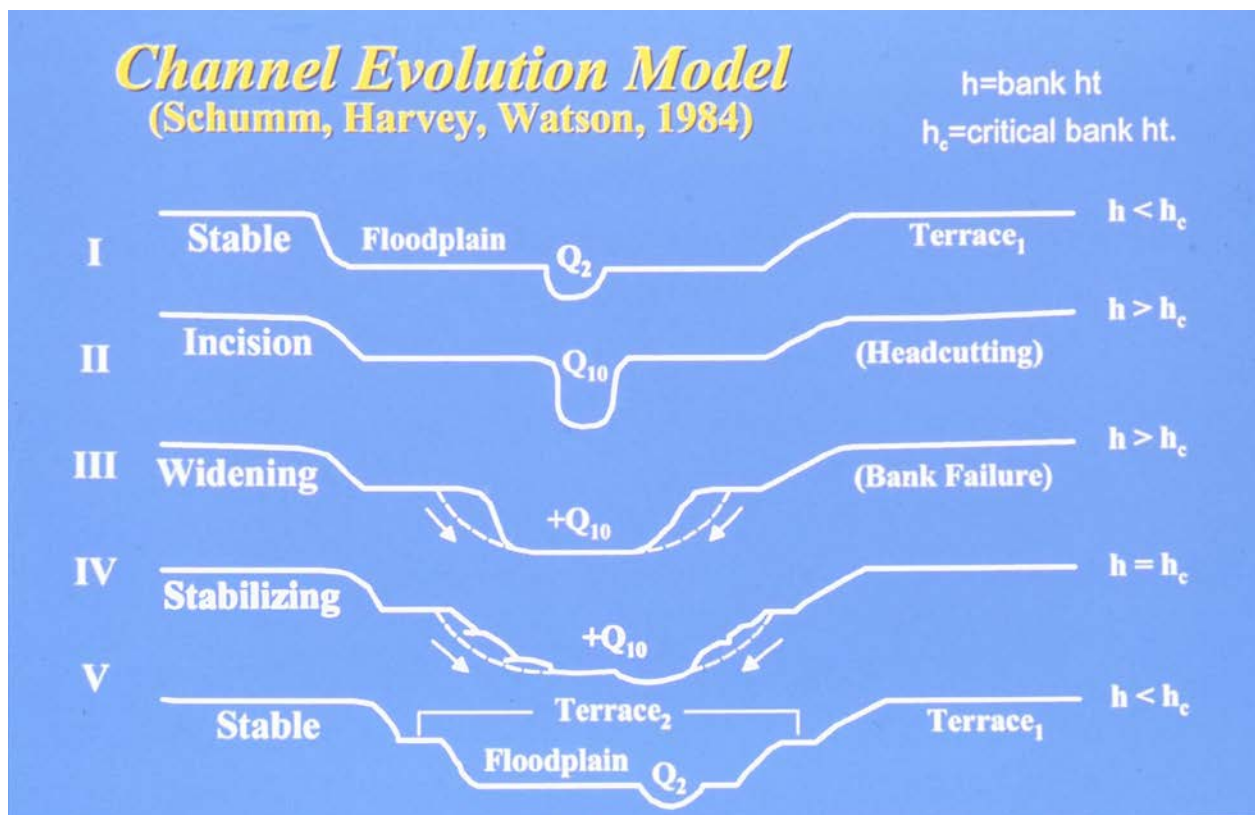
For the County-wide stream inventory, the Channel Evolution Model (CEM) is the primary tool used to assess the physical condition of streams and prioritize restoration need. The CEM uses several field indicators to describe morphological conditions and the degree of departure from equilibrium. Such indicators include active and abandoned floodplain features, headcutting/downcutting, vertical and concave streambanks, bank slumping, meander-bend migration, and streambed aggradation. Each of these indicators helps to define existing conditions and predict future morphological adjustments. The general CEM model diagram is shown in Figure and the complete field worksheet is included in Appendix A.

The CEM is comprised of five geomorphic stages that can be identified through application of the field indicators described above. Stage I represents the stable/equilibrium condition where energy contained in stream flow is balanced by resistance of sediment flow and other channel features. This balance in energy distribution is achieved through appropriate integration of the physical characteristics associated

with channel plan-form, cross-sectional shape, and streambed profile. Stage I systems typically possess a relatively small main channel capable of handling the full range of flows up to and including channel forming and maintaining (bankfull) discharge. This channel is well connected to an active floodplain that serves to spread and dissipate energy in flows exceeding bankfull. Stage I systems are usually relatively easy to identify because they demonstrate consistency and predictability in channel form while exhibiting minimal signs of erosion and sedimentation.

A disruption in the balance between stream flow and sediment flow typically initiates Stage II, or Incision. Excess energy contained in more frequent high velocity flows is transferred to the streambed resulting in headcutting and/or downcutting. As the stream cuts a course deeper in the valley floor, streambanks become higher and steeper ultimately reaching a critical bank height or threshold of stability. When the critical bank height is exceeded streambanks begin to fail through slumping and mass wasting processes. Slumped material is washed away during significant discharge events as the system transitions from Stage II to Stage III, Widening.

Degraded stream systems typically exhibit an overlap of the evolutionary stages of adjustment, and, at times several stages may occur concurrently in the system. For example, it is not unusual for Stage II (Downcutting) and Stage III (Widening) to occur at the same time in a given stream reach, especially in an urbanizing watershed experiencing radical changes in hydrologic and sediment regimes. Stages II and III are of most concern because both represent active stages of erosion, with downstream sedimentation, habitat degradation, and infrastructure damage of significant concern.
